Conclusion-Landslide in Embankments

3.1.1 Landslide caused by icing

3.3 冻土退化导致地基沉降及工程对策

4. 多年冻土退化引发的环境地质问题

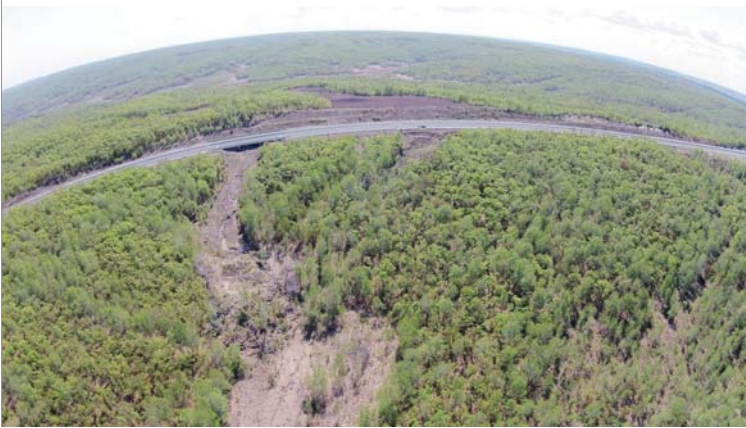
K178+550滑坡加宽侧以桥代路

Using bridge to instead original road near K178 + 550 landslide

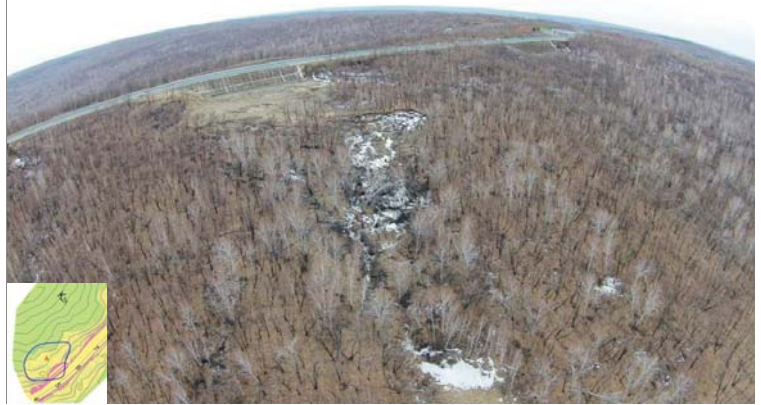
K177+550滑坡虽经抗滑桩支挡，旧滑坡前缘出现新滑坡

set anti-slide pile(17*24m, DIS 3m), the second creep landslide occur ahead

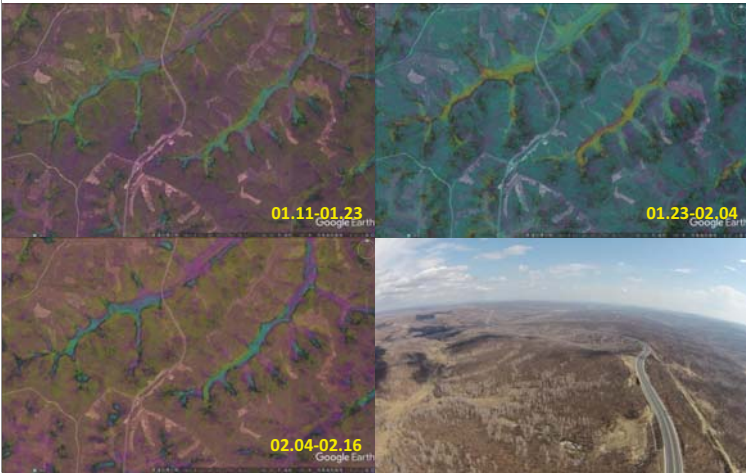
滑坡路段2017.01.11-02.16时段SAR干涉图

SAR interferogram (2017.01.11- 2017.02.16)

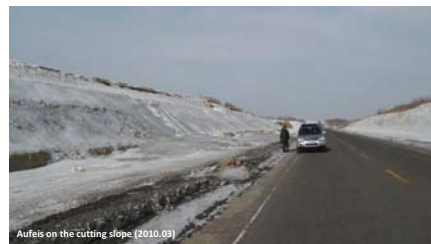
Aufeis on the cutting slope (2010.03)

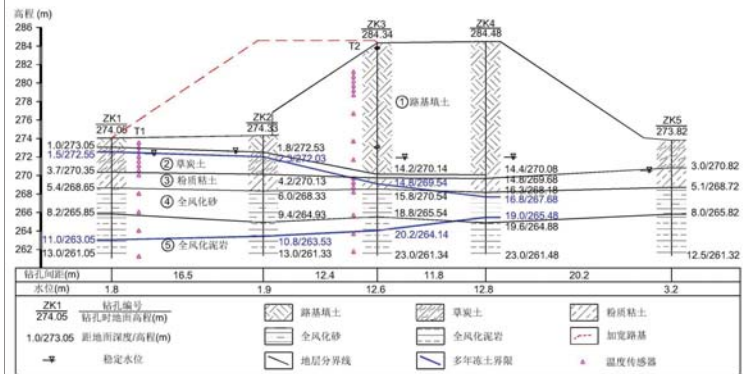
K161+440断面监测孔布置、地质剖面示意图

Monitoring hole layout, geological profile diagram
