Conclusion-Landslide in Embankments

3.1.1 Landslide caused by icing

3.3 冻土退化导致地基沉降及工程对策

4. 多年冻土退化引发的环境地质问题

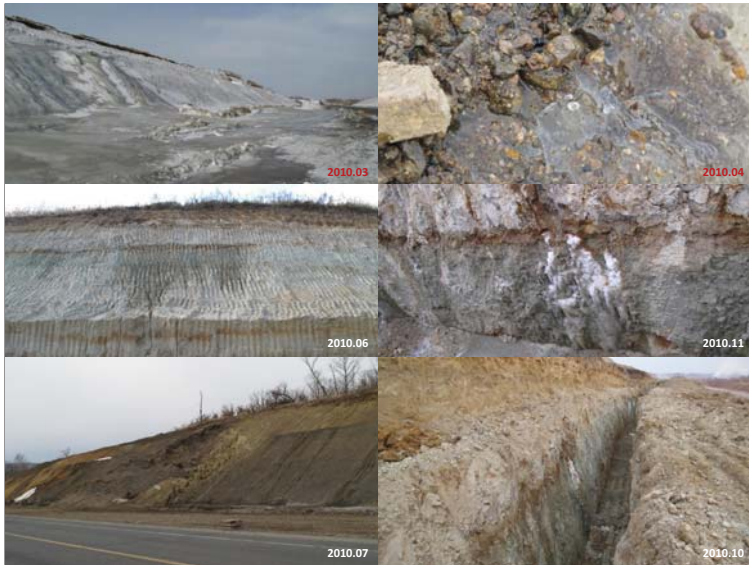
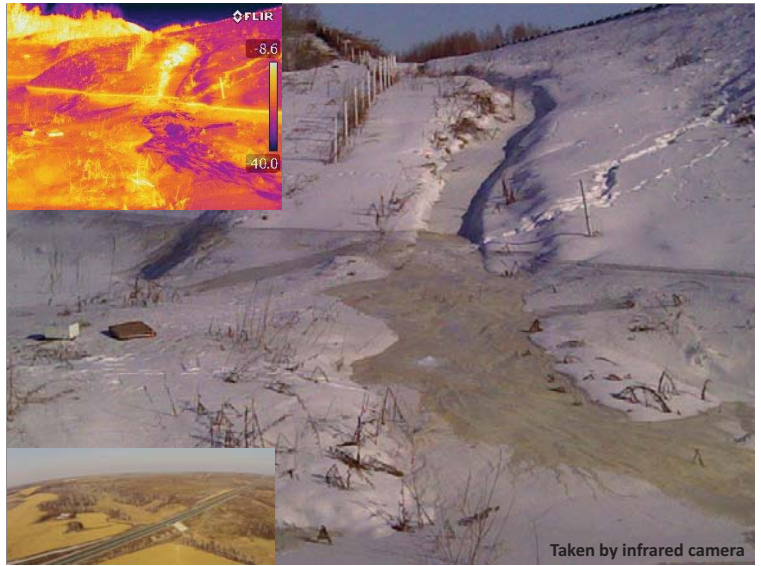
Monitoring(2011~2015):

- At the second floor of the slope, near the toe of the slope, four drilling borehole(space,40m).
- Soil temperature, water content, pore water pressure for 5 years.

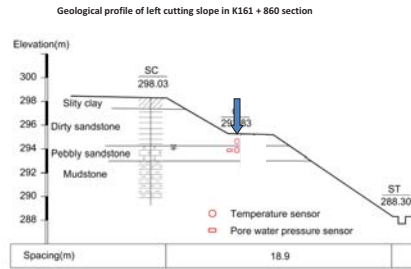
Drilling exploration(2010.07):

- At the top of the hill.
- Soil samples was conducted particle analysis and penetration tests.
- Different soil layer is very important for icing here.

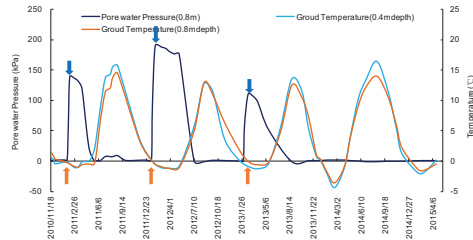
Signal of icing :

- Icing is related to soil PWP around here. The signal of it is a sudden increasing of soil PWP accompanied by soil temperature dropped to 0 °C.(frozen front)

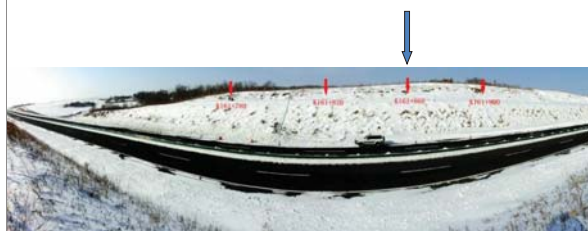
Icing cycles:

- Occurrence, bigger, smaller, disappearance...
